Alfred Kärcher GmbH & Co. KG

iSolar800 Cleaning System

Cleaning Action and Handling

DLG Test Report 6103 F

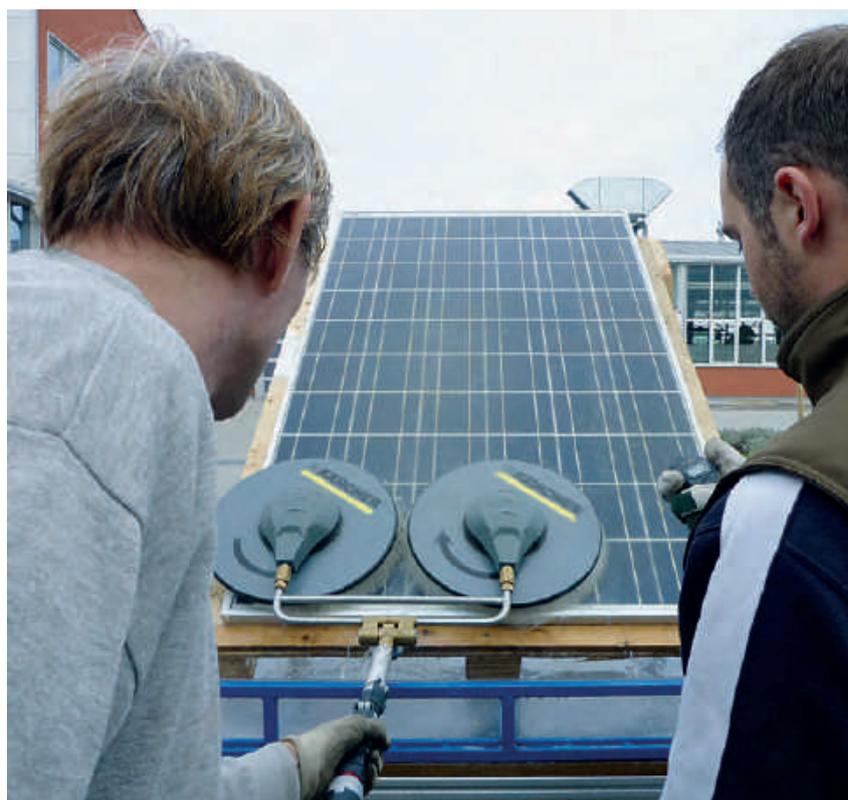
Image 2:
Module cleaning during laboratory test

The module was cleaned for 30 seconds from top to bottom on the left-hand side. For the other 30 seconds, the module was cleaned on the right-hand side from bottom to top (See Image 2).

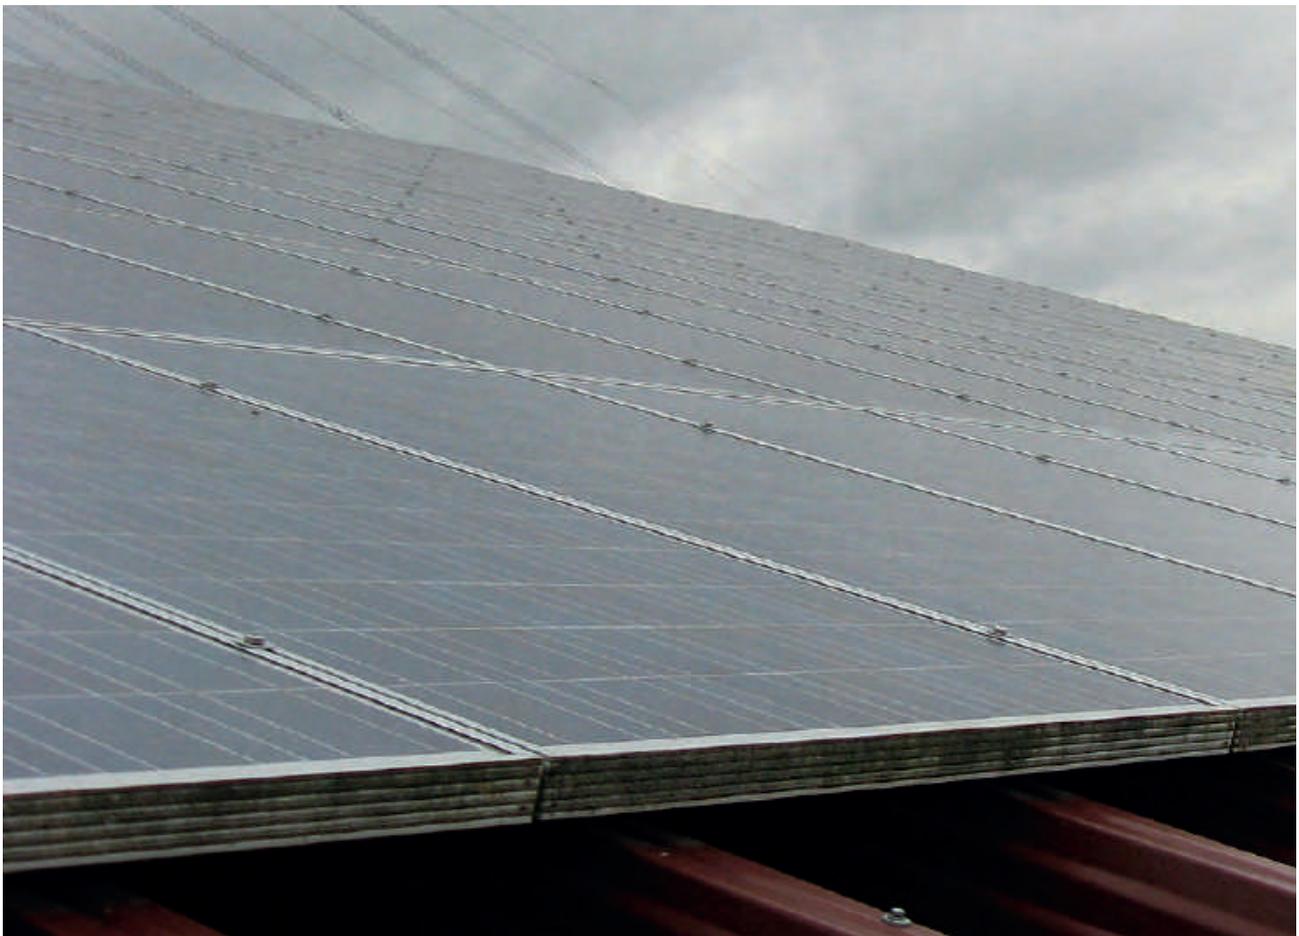
Image 5:
Comparison between cleaned modules (lower row) and uncleaned modules (upper rows)

With cleaning, the performance and output of String 2 further improved. In the foreground of Image 5, the cleaned modules (lower row) are visible. All rows located higher were not cleaned.

Optically, clear differences in the gloss can be seen.

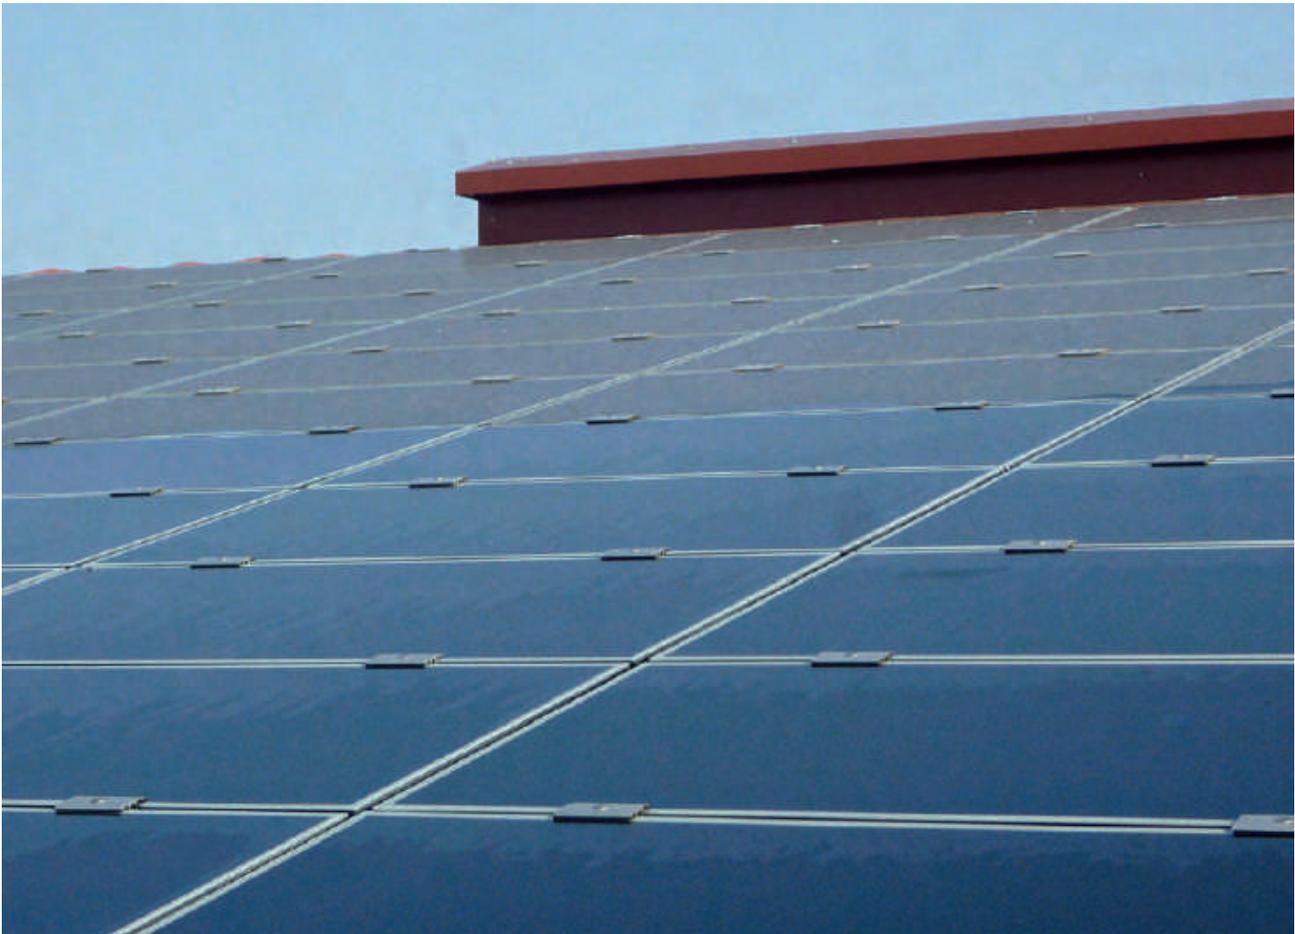
Image 6:
Comparison between cleaned modules (lower rows) and uncleaned modules (upper rows) at Farm 2

In the foreground of Image 6 the cleaned modules are visible (the 5 visible lower rows). All rows located higher were not cleaned.

Optically, massive differences in the gloss can be seen which were

also confirmed in the measurement of the gloss level (see section on gloss level).

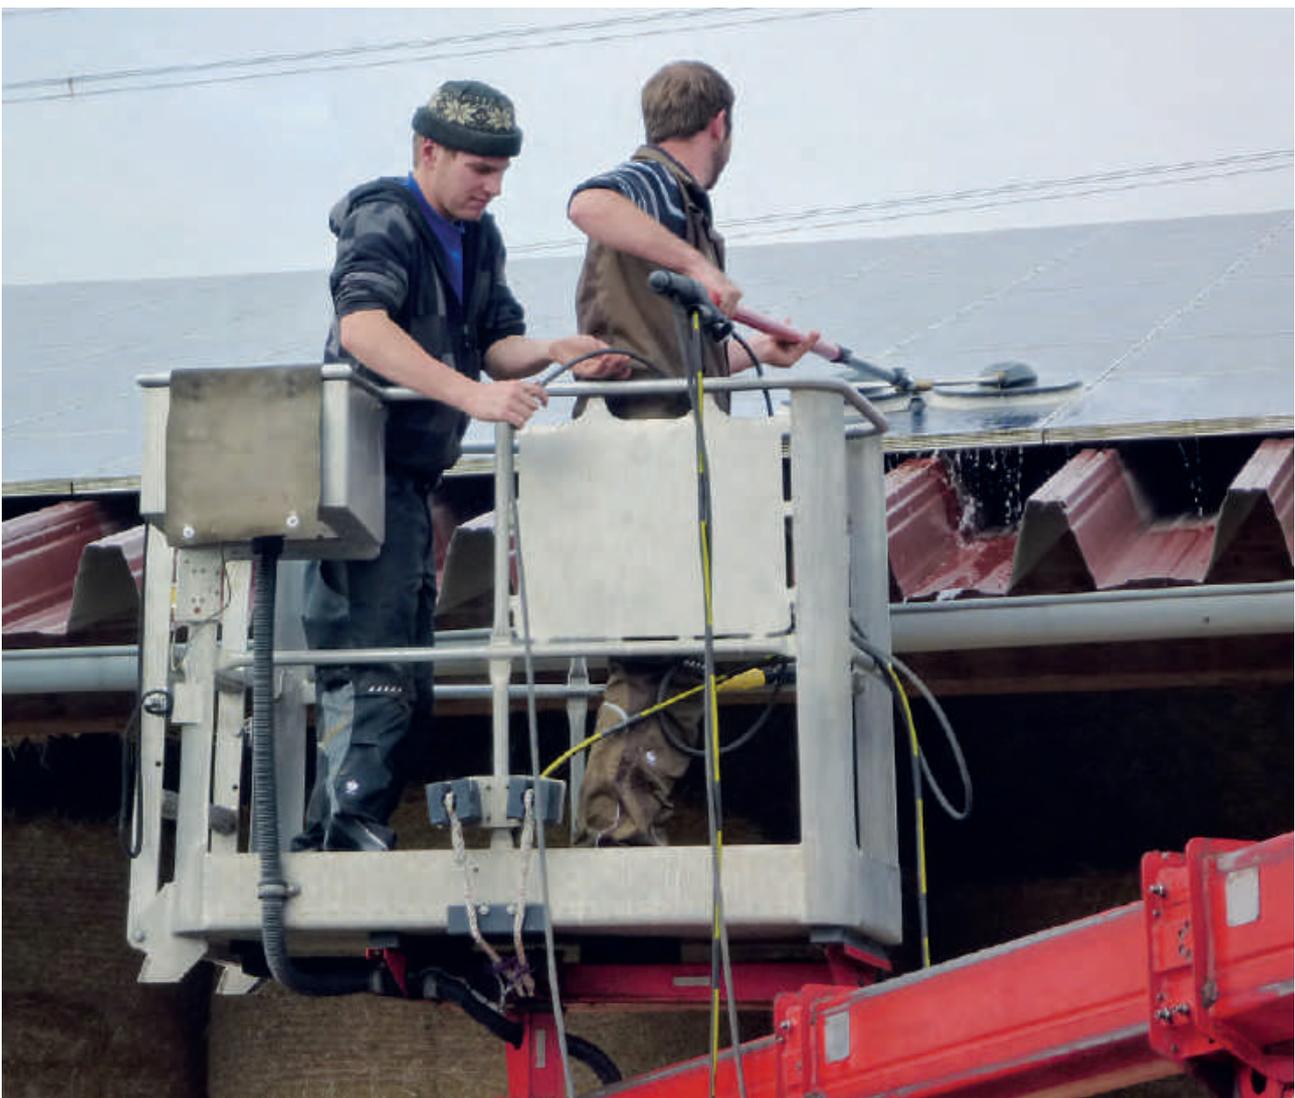
Image 7:
Cherry picker occupied by two people for cleaning upwards.

At both farms, in addition to the performance effects, the practical application in relation to the system's functional reliability and occupational and operational safety was evaluated. In addition, two possible approaches could also be compared. Firstly, the cleaning can be carried out from the crest of the building roof with the operator secured with a harness and the modules cleaned from top to bottom (see Image 8). Alternatively, the modules can be cleaned from bottom to top with the operator working in a cherry picker at the level of the eaves (see Image 7).

movements, e.g. operating the cherry picker, handling the hoses or operating the high pressure washer (compare Images 7 and 8). Working in a pair eases the cleaning process and increases safety.

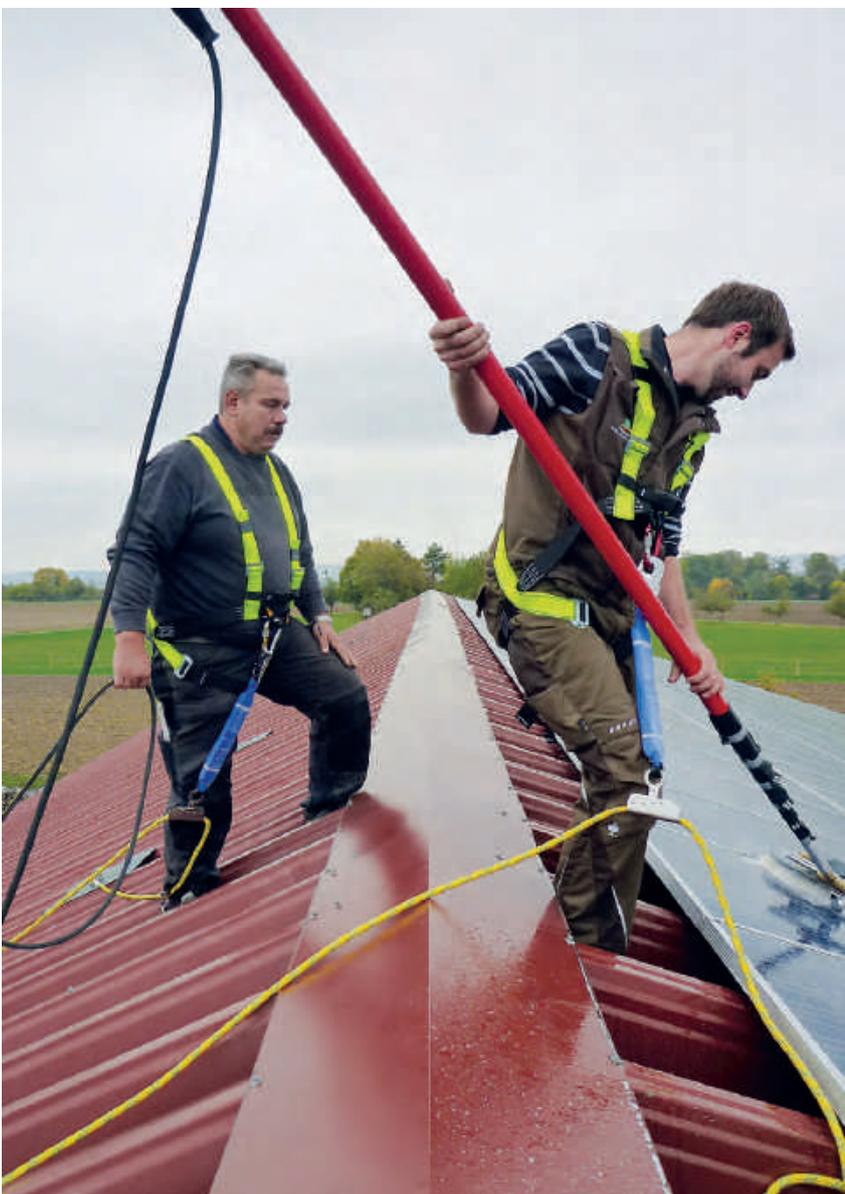
Image 8:
Two people on roof cleaning downwards.
